# **Los Angeles City Fire Department**

## **Informational Summary Report**

#### **Injuries/Commercial Structure Fire**

**May 16, 2020  
Boyd Incident  
CA-LFD-001073**

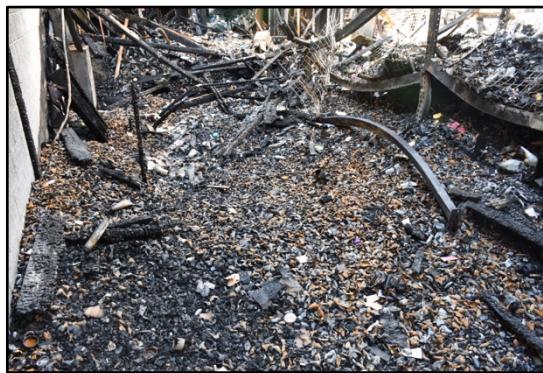
Spent Nitrous Oxide Chargers in Unit B

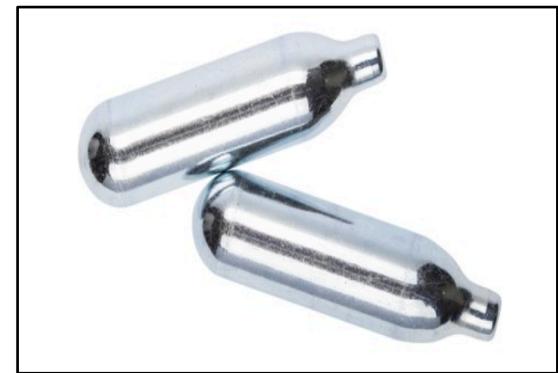
Nitrous Oxide Chargers 8oz.

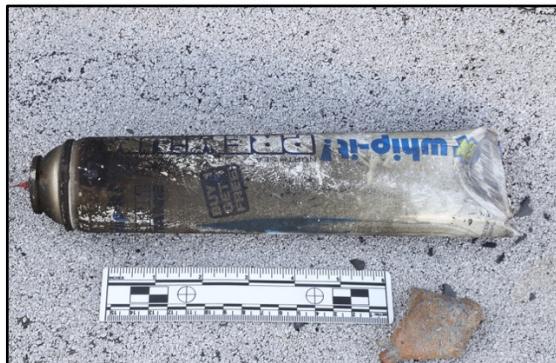
Butane Canisters

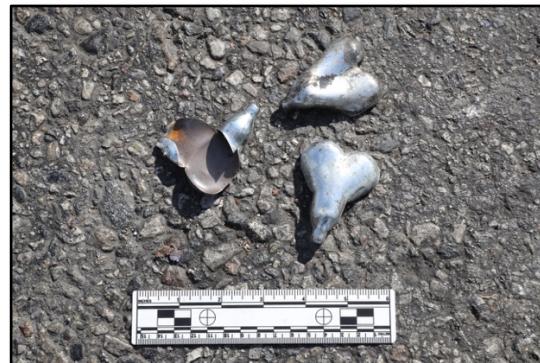
Spent Nitrous Oxide Chargers

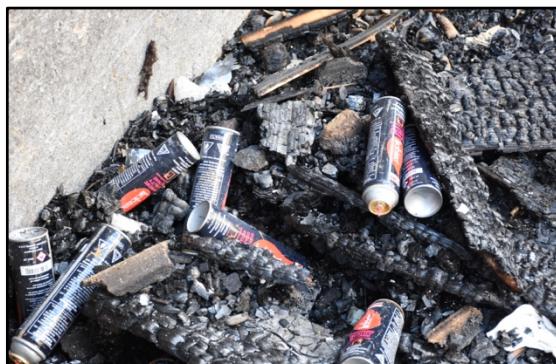
Butane Canisters in Unit B

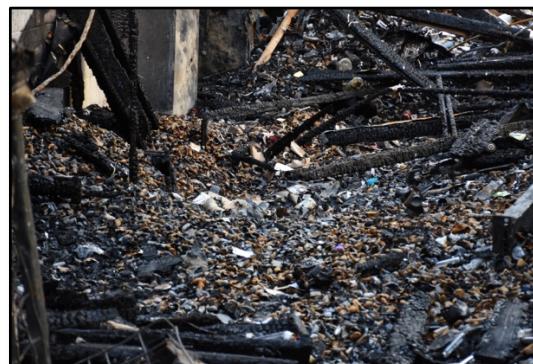
Spent Nitrous Oxide Chargers in Unit B

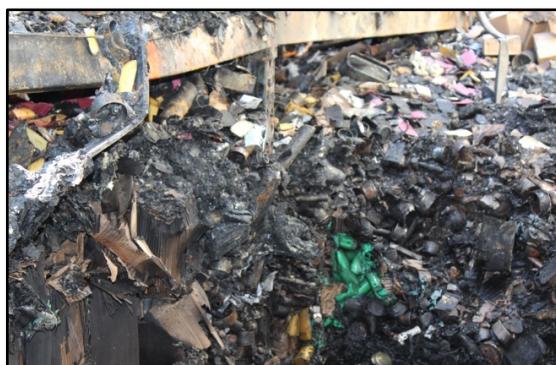
Contents in Unit A

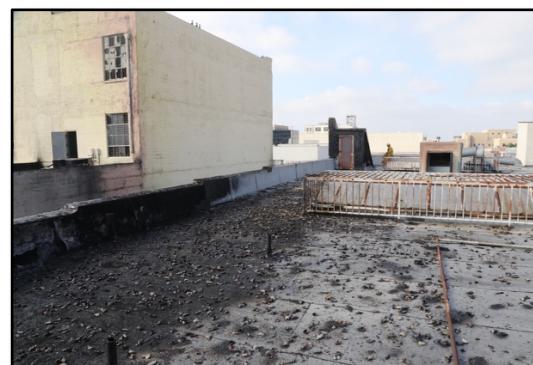
Nitrous Oxide Chargers on Bravo exposure roof

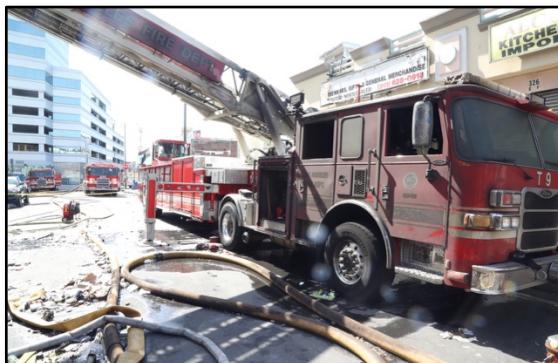
Aerial Ladder Truck Tractor and Trailer damage

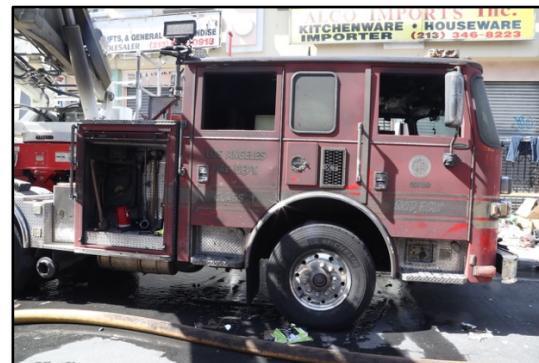
Aerial Ladder Truck Exterior Cab damage

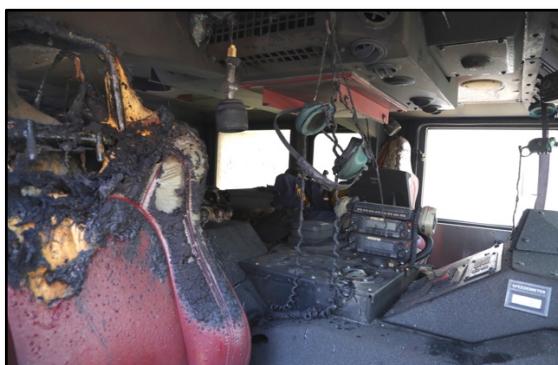
Aerial Ladder Truck Interior Cab damage

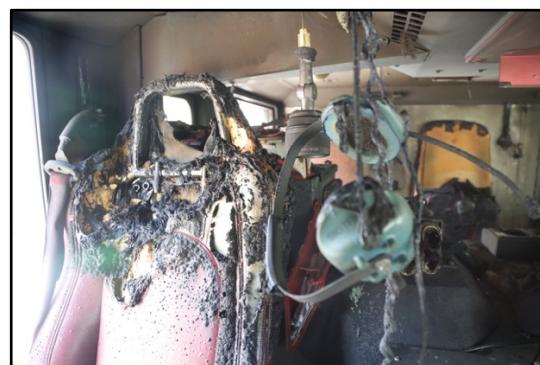
Aerial Ladder Truck Interior Cab damage

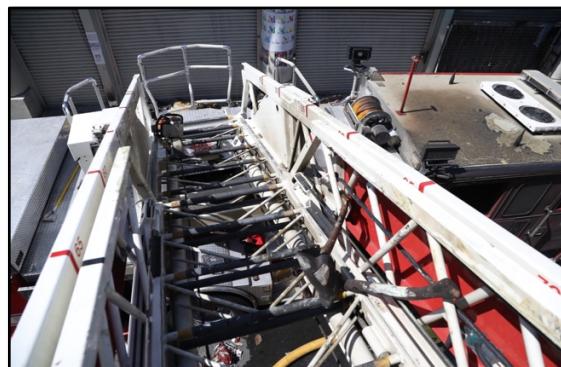
Aerial Ladder and Equipment damage

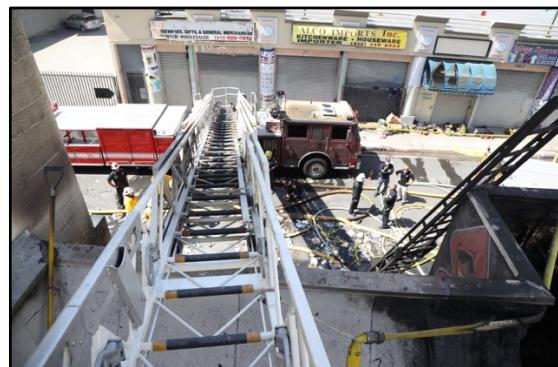
Aerial Ladder damage

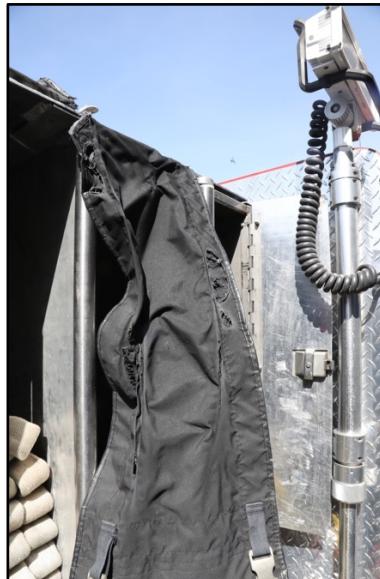
Engine hose cover damage

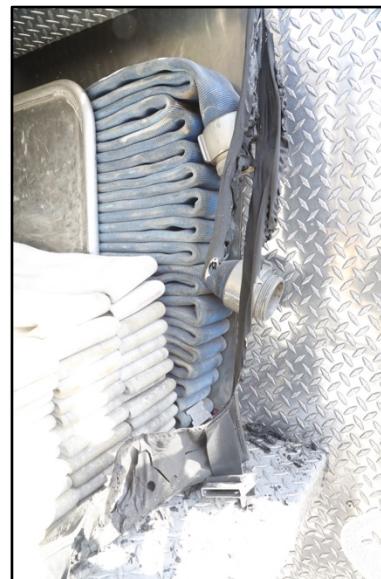
Engine hose cover damage

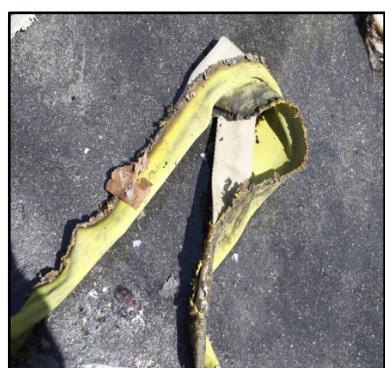
1 ¾" hose line damage

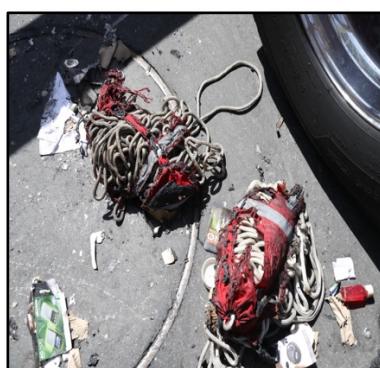
Drop bag damage

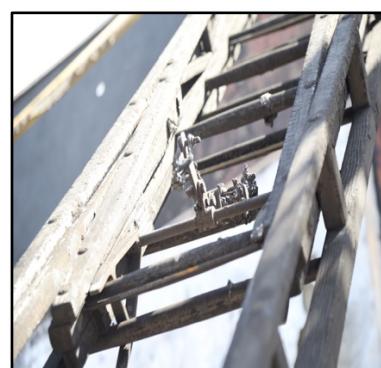
35' Extension Ladder damage
