# **Los Angeles City Fire Department**

## **Informational Summary Report**

#### **Injuries/Commercial Structure Fire**

**May 16, 2020  
Boyd Incident  
CA-LFD-001073**

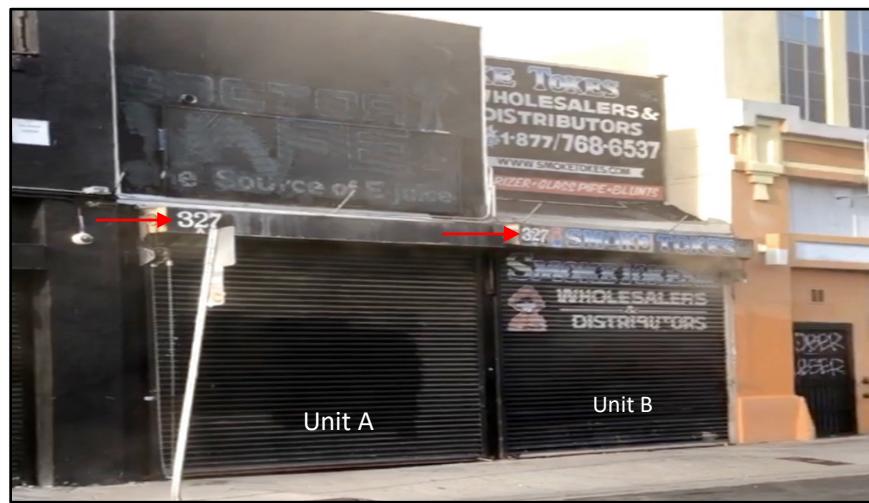
The building was approximately 25' wide by 110' long and located in a row of commercial occupancies. The one-story fire building was flanked by a two-story commercial building to the West (Bravo Exposure) and a four-story commercial building to the East (Delta Exposure). The involved structure was constructed of cinder block walls and was divided into two separate occupancies by a partition wall running from the front to the back (North to South), with a mezzanine in the middle. The store front was secured with two rolling steel doors, identified as Unit A (left side) and Unit B (right side). Closed at the time of alarm, the store was doing business as a wholesale and distribution center for supplies associated with dispensaries and cannabis smoke shops. There was excessive storage present in both of the units, and the building was not sprinklered. (See complete building description and photos under Conditions on page 16)

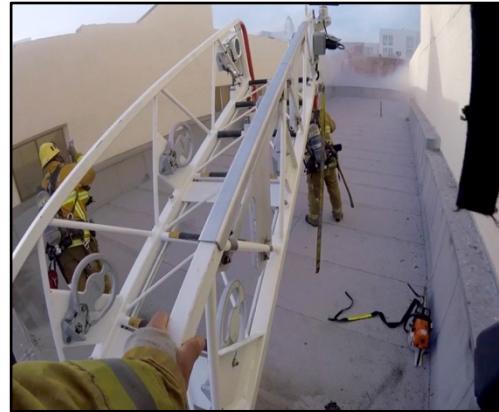
At 18:33:40 hours, A/O made an inspection cut and small hole towards the Alpha/Bravo corner, out of the way of the path of travel. Once completed, pressurized, brown smoke exited out of the hole.

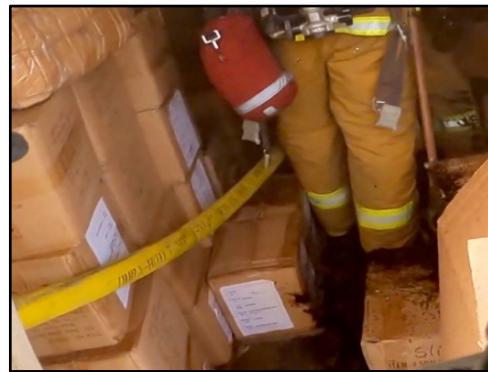
The aisleway to Unit A was approximately 42" wide and was strewn with boxes and copious amounts of melted candle wax. The cluttered aisle was lined with commercial storage racks on either side. In the front, they were loaded with boxes, stacked to the ceiling, comprised of glass jars, candles, vapes, pre-rolled cones and various smoking products. In the rear portion of the occupancy, pallets of boxes blocked the aisleway.

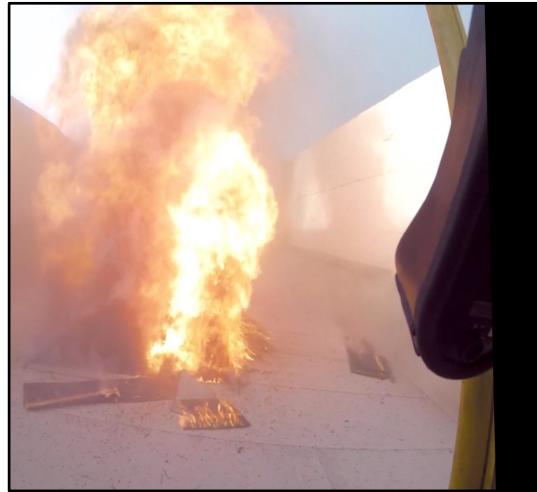
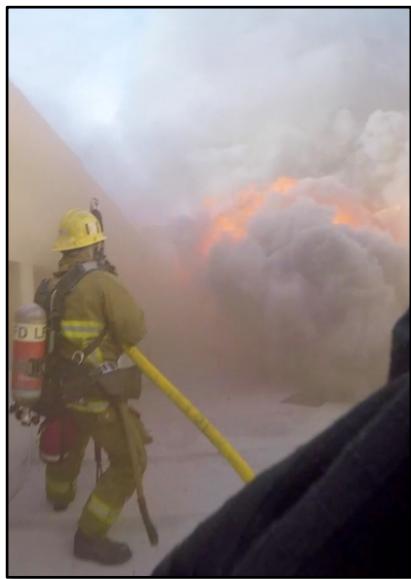
Heavy fire pushed out of the ventilation hole, forcing the roof team to back away from the operation. Deciding to don structural gloves at this point, A/O gave the chainsaw to TILL and provided direction for TILL to start a new ventilation hole approximately 6' back from the initial heat hole and to work against construction. TILL initiated a new ventilation hole and the roof team began to pull the material. Pressurized smoke surged from both ventilation holes and the flames that followed were approximately 20' to 30' high.

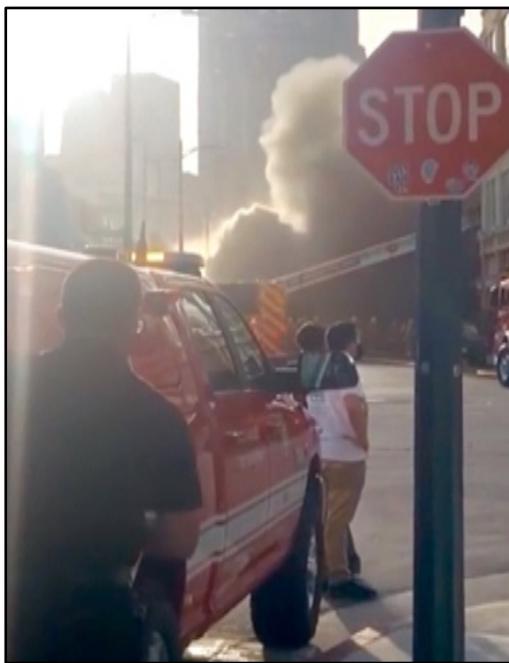
At 18:38:42 hours, in the front of the building, "dirty" black smoke pushed out from Unit A across the street, enveloping the firefighters operating in front of and adjacent to the involved occupancy. As they backed up from the entrance, the smoke ignited, sending approximately 30' flames across the street and into the air.

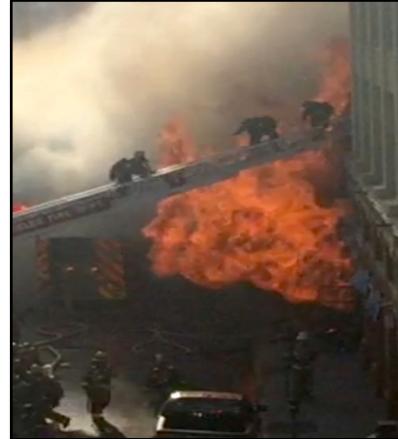
On the Alpha side, flames disappeared momentarily and the smoke appeared to temporarily diminish. Then without warning, an enormous fire ball blowtorched out of the structure reaching across the street. The fire ball emanated from the front of Unit A, followed by Unit B. Fire was seen reaching the buildings across the street and rising into the atmosphere approximately 60' high above the roof line. It scorched everything in its path, including the Truck and the rear portion of the Engine.

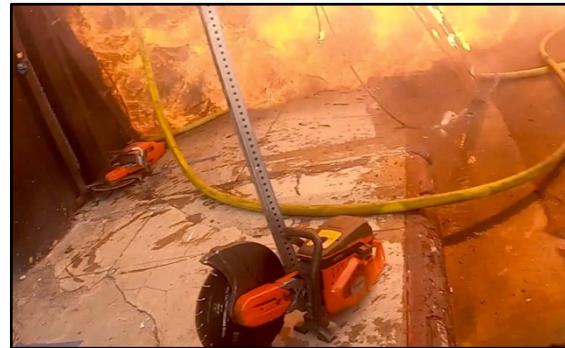
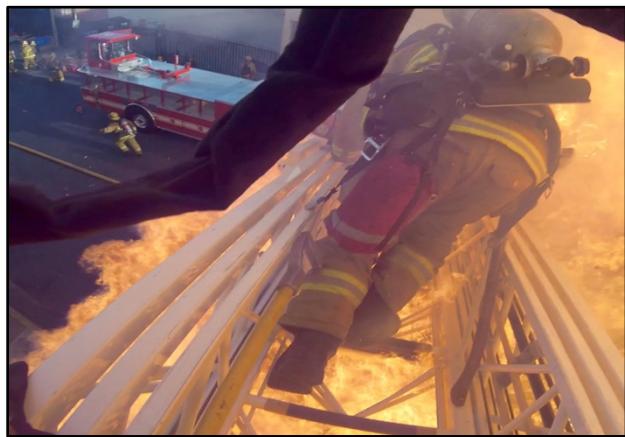
As the remaining roof team mounted the aerial ladder, flames completely engulfed the rungs, cutting off their escape. TOP descended the aerial ladder with the chainsaw. As he attempted to step on each rung, the concussive force that followed the fire ball caused his foot to slip under the rung and halted his progress. At that moment, he was enveloped by the fireball. At the same time, A/O and CII transitioned from the

roof and moved quickly down the aerial ladder behind him. CII and A/O caught up with TOP who was struggling to get loose from being trapped in the rungs. CII ran into A/O and propelled him into TOP, who had broken free and resumed his descent on the rungs. TOP fell once again as A/O unintentionally toppled over him from behind.

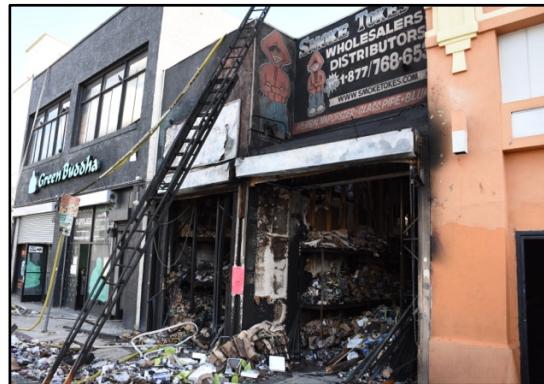
Alpha side looking toward the Bravo exposure

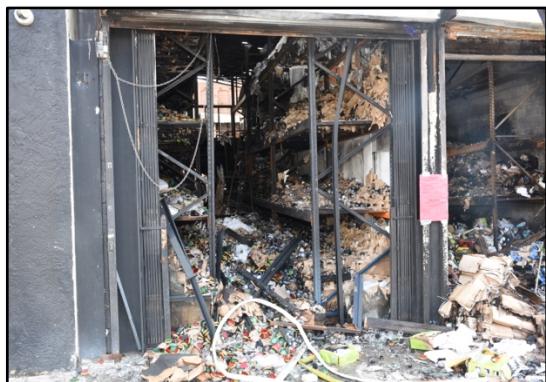
Alpha side looking into Unit A

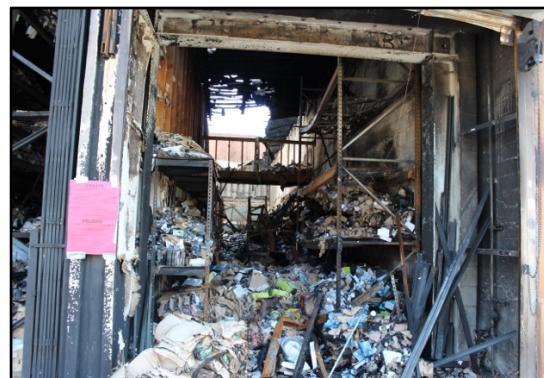
Alpha side looking into Unit B

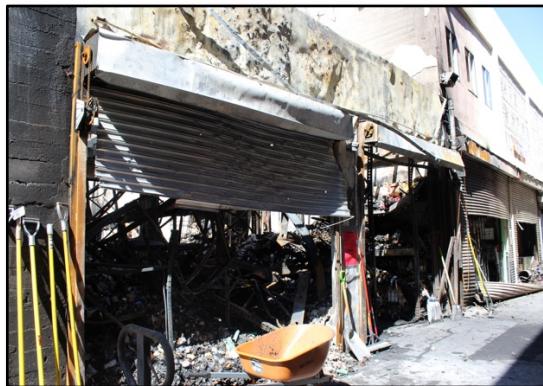
Charlie side looking towards the Bravo exposure

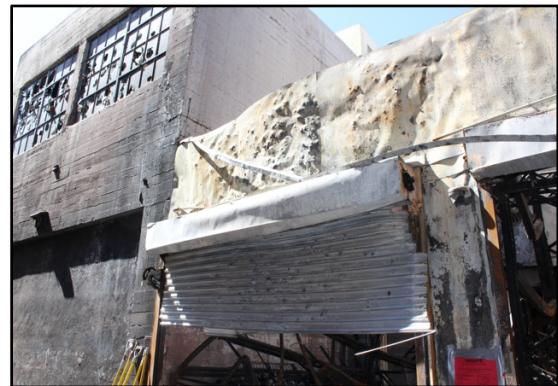
Charlie side looking towards the Delta exposure

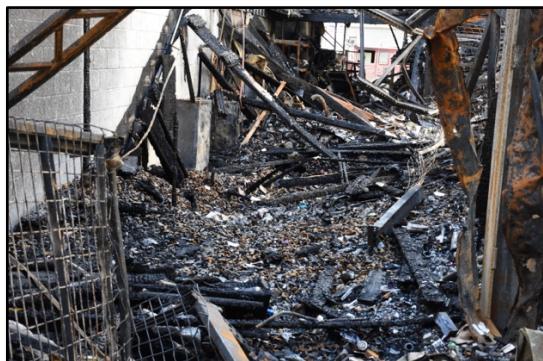
Charlie side looking into Unit B

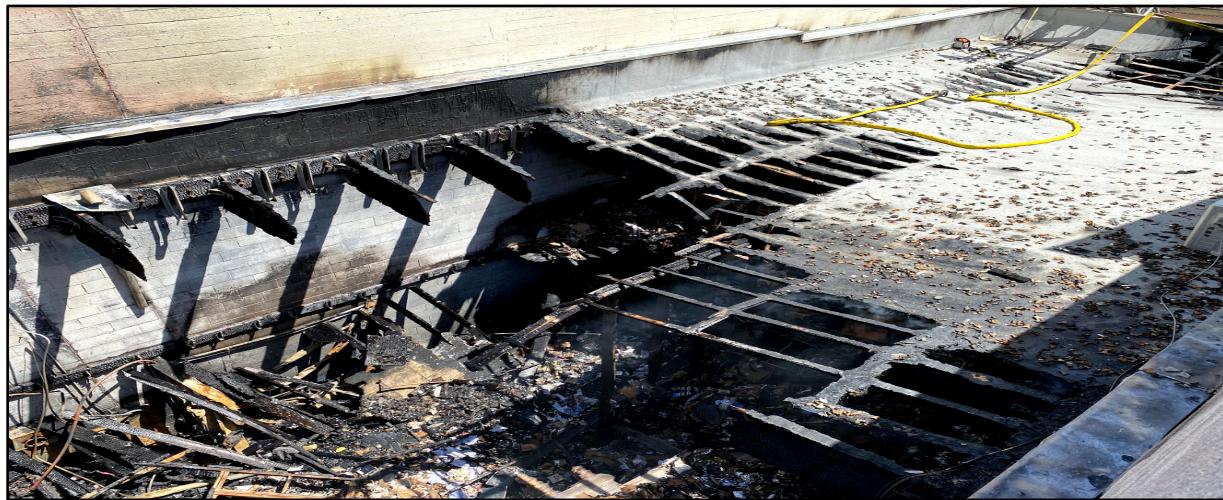
Perspective of roof from Bravo exposure looking back towards the Alpha side

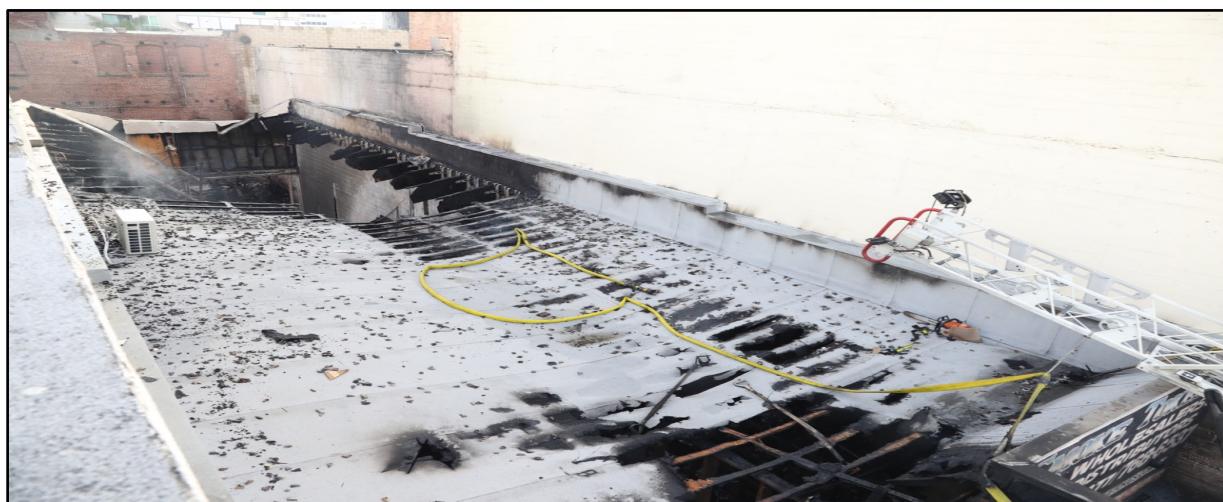
Perspective of roof from Bravo exposure looking back towards the Charlie side

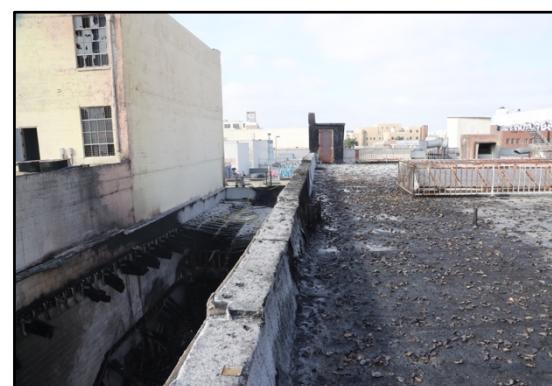
Perspective looking at Bravo rooftop

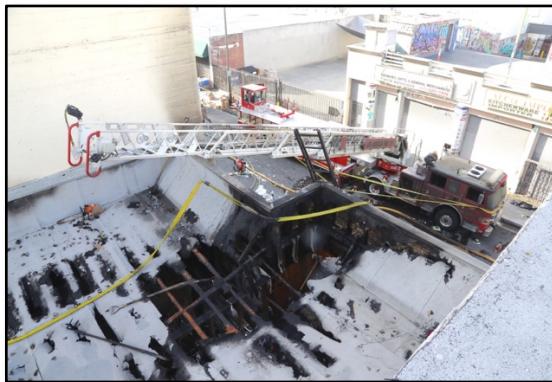
Aerial Ladder placement

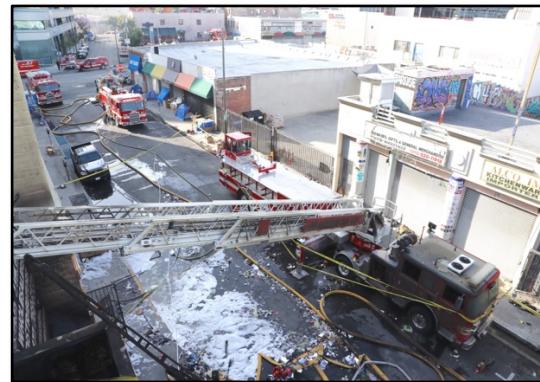
Aerial Ladder Truck placement

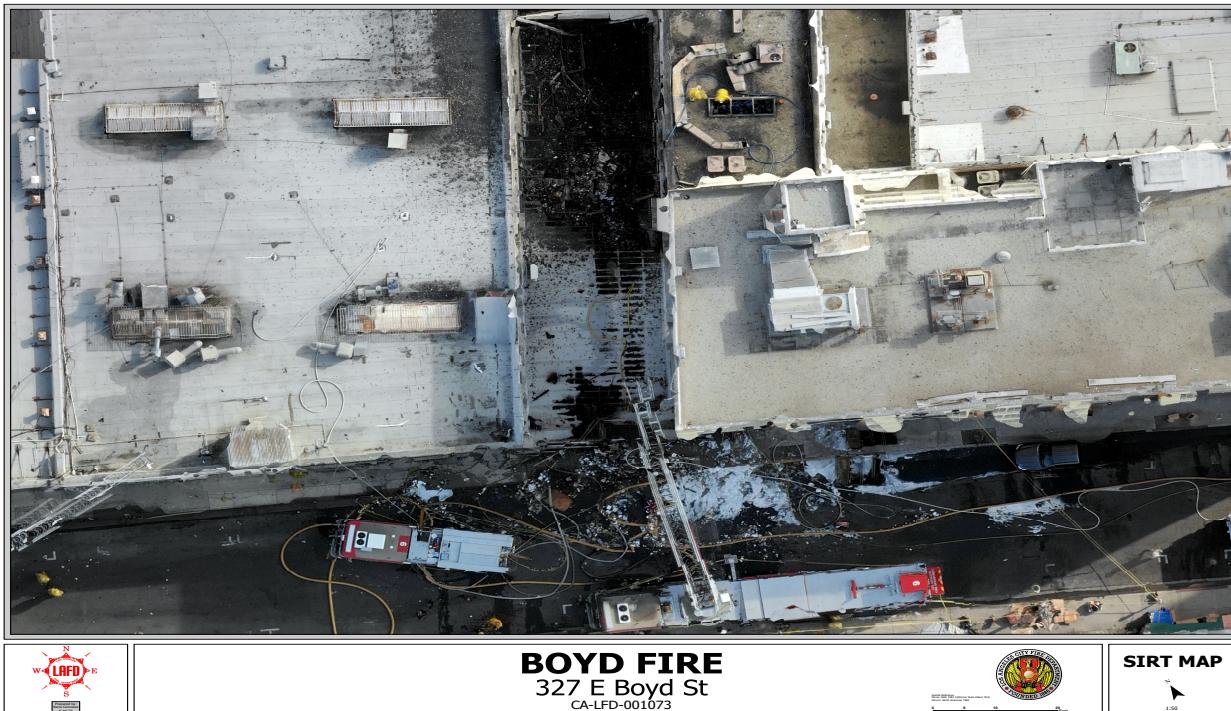
Aerial drone imagery from overhead perspective

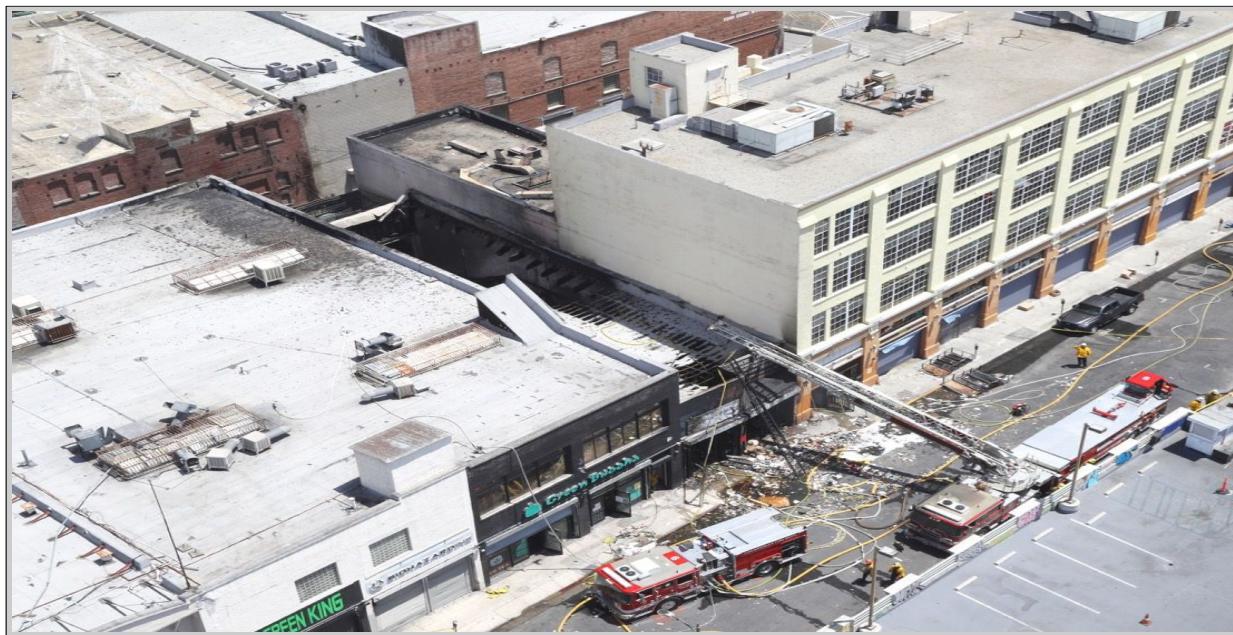
Aerial drone photography from the West (Alpha/Bravo) perspective

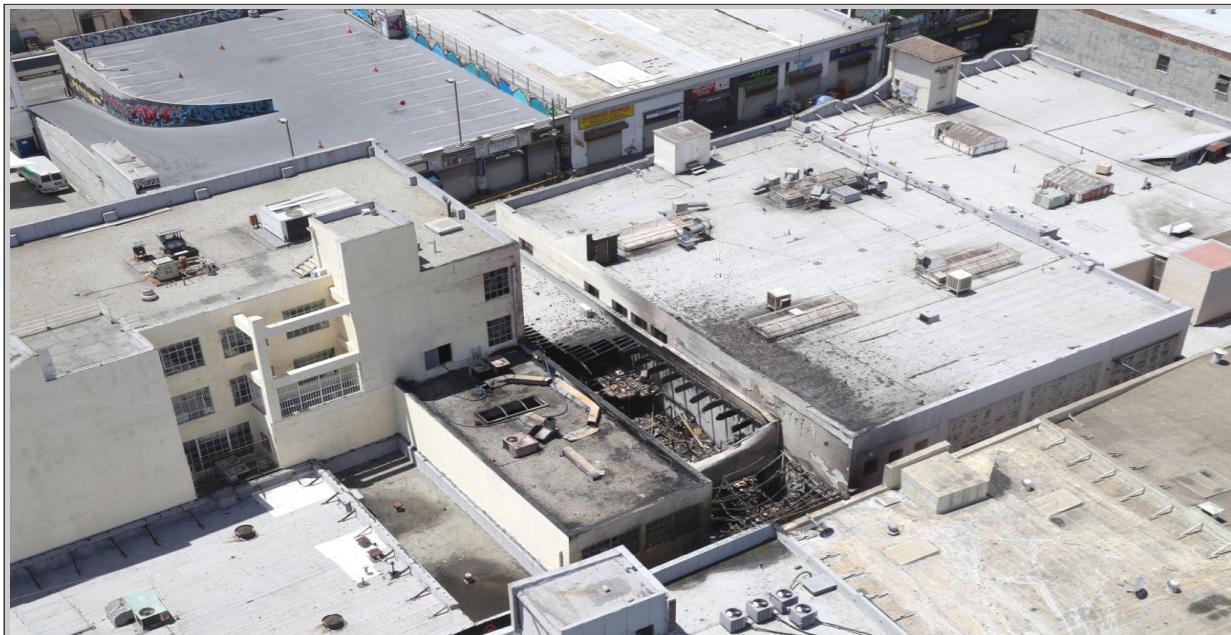
Aerial photography from North/East (Charlie/Delta) perspective

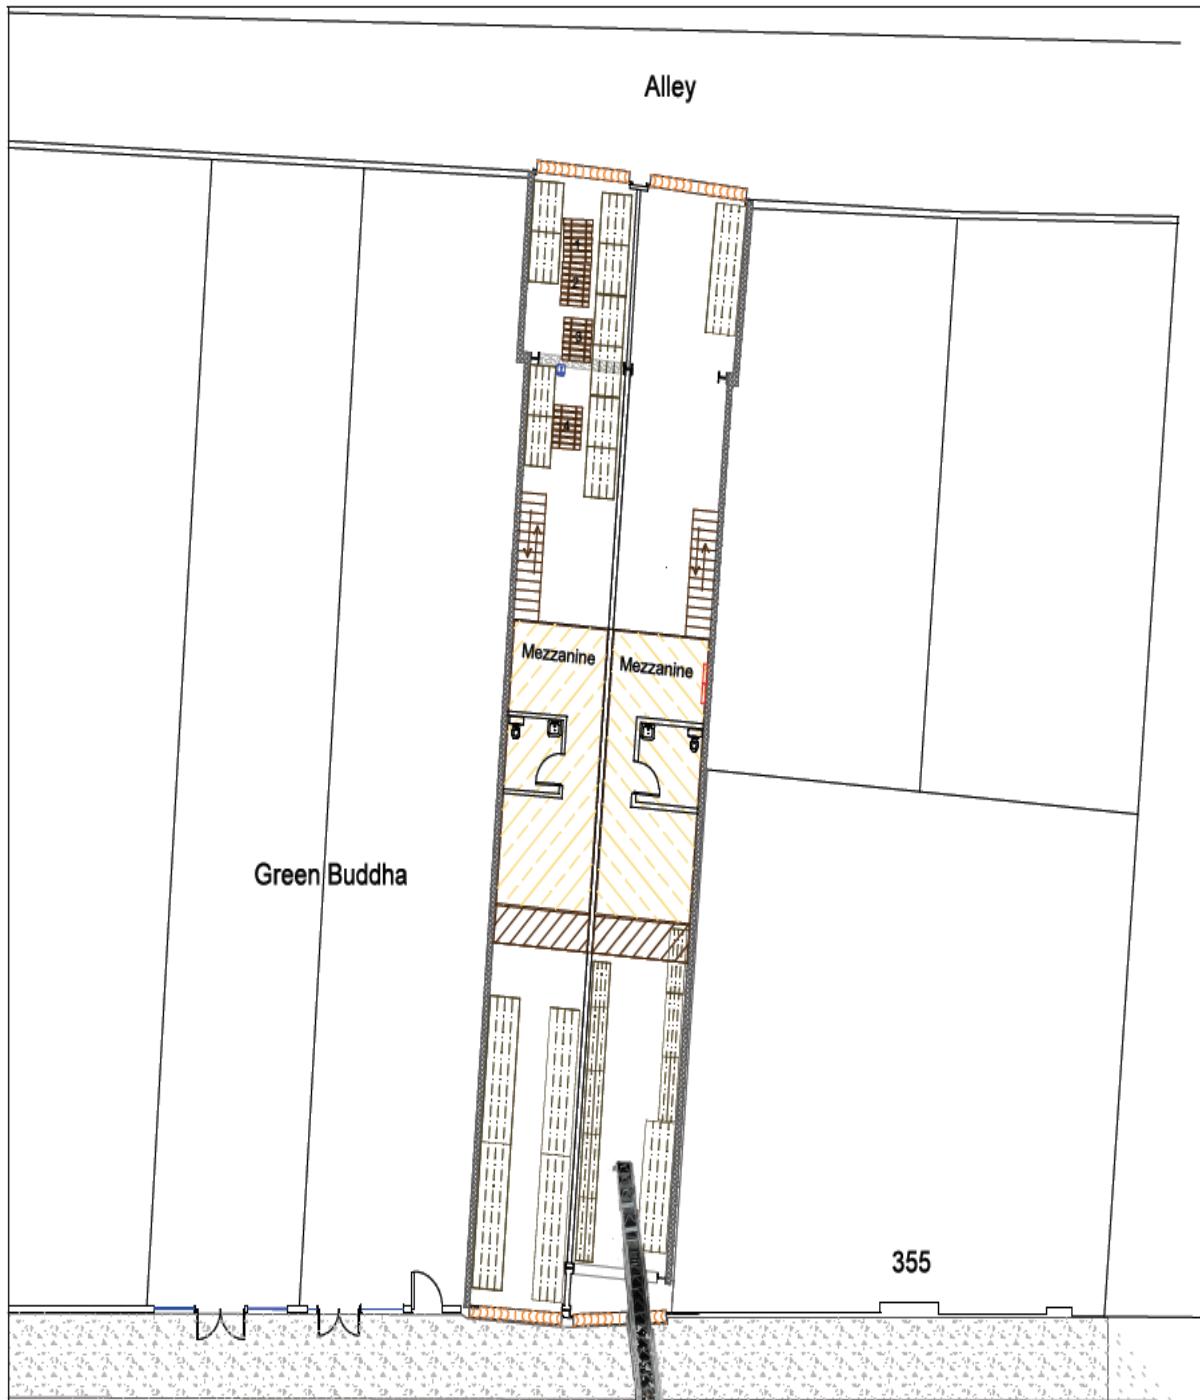
2-D image of 327 East Boyd Street (Courtesy of NRT)
